Manhole Inspection Summary

Manhole # S29Q__029MH

Insp Date: **11/6/08 9:11 AM**

Location Address: **610 W. West**

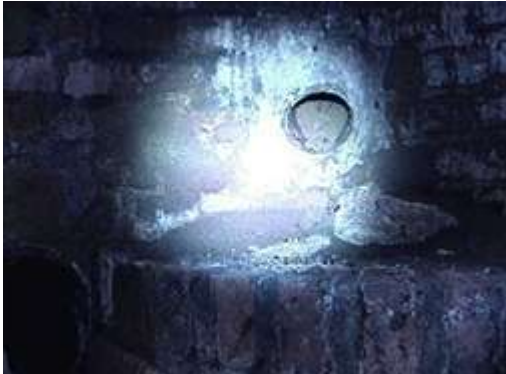
blocked pipe

at the 10 oclk

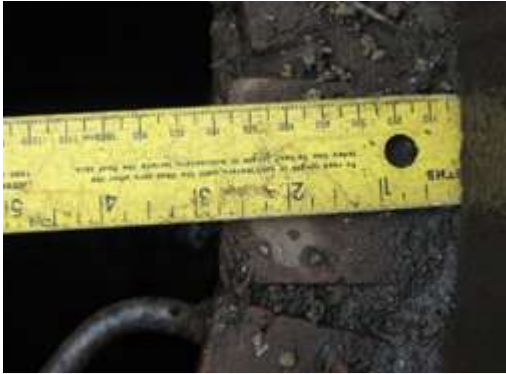
Defect 5

Offset: **2.** (in.)
75

offset 2.75"

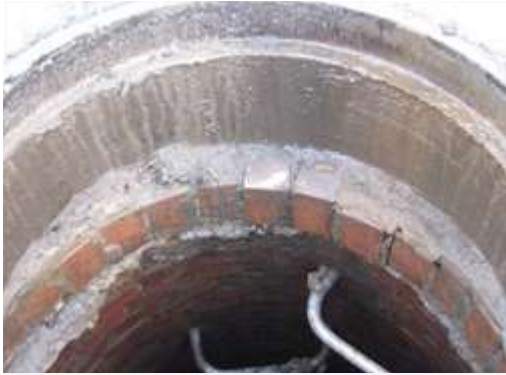
Defect 4

Condition: ☐ Sound ☐ Cracked ☒ **Leaks**

infiltration from frame

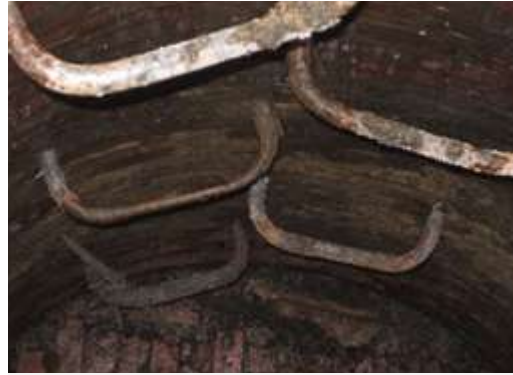
Defect 3

Count: **6** Missing: **0** ☒ **Corroded**

corroded rungs

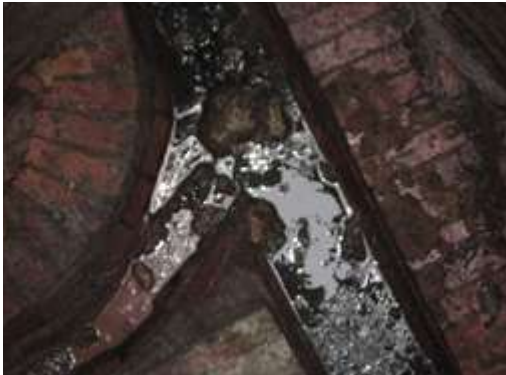
Defect 2

Condition: ☐ Sound ☐ Cracked ☐ Root Intrusion ☐ Deteriorated ☐ Leaks ☒ **Debris**

debris in channel

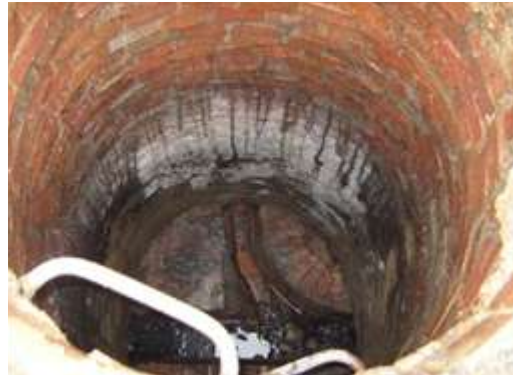
Defect 1

Infiltration: ☐ None ☐ Joint ☐ Cracks ☐ Mortar ☐ Roots ☒ **Wall**

infiltration in corbel wall

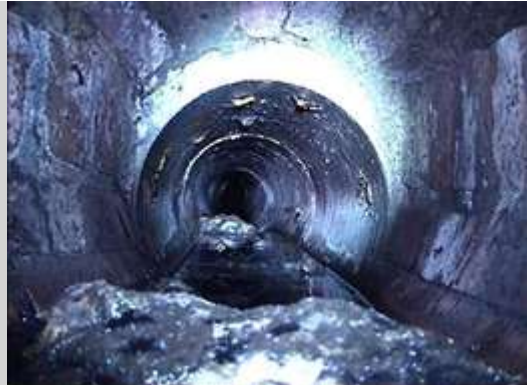
12 O'Clock Outflow

Pipe Height: **10.8** (in.) Rod and Bar (Angled)
Pipe Material: **Clay** ☐ Pipe Lined
Invert Depth: **10.58** (ft.) Flow Characteristics: **Slow**
Deposits: ☒ None ☐ Mud ☐ Sludge ☐ Debris ☐ Grease
Silt Depth: **0** (in.) Deposits Extent:
Infiltration: **None** Pipe Seal Cond: **Sound**

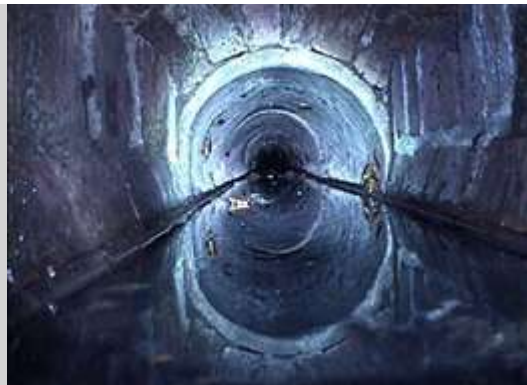
6 O'Clock Inflow

Pipe Height: **10.8** (in.) Rod and Bar (Angled)
Pipe Material: **Clay** ☐ Pipe Lined
Invert Depth: **10.55** (ft.) Flow Characteristics: **Slow**
Deposits: ☒ None ☐ Mud ☐ Sludge ☐ Debris ☐ Grease
Silt Depth: **0** (in.) Deposits Extent:
Infiltration: **None** Pipe Seal Cond: **Sound**

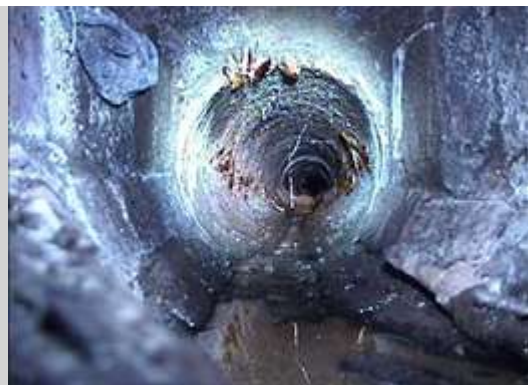
8 O'Clock Inflow

Pipe Height: **8.4** (in.) Rod and Bar (Angled)

Pipe Material: **Clay** ☐ Pipe Lined

Invert Depth: **10.40** (ft.) Flow Characteristics: **Slow**

Deposits: ☒ None ☐ Mud ☐ Sludge ☐ Debris ☐ Grease

Infiltration: **None** Pipe Seal Cond: **Sound**
